Exhibit F

ASAIO Journal 1998

Comparison of the *In Vivo* Behavior of Polyvinylidene Fluoride and Polypropylene Sutures Used in Vascular Surgery

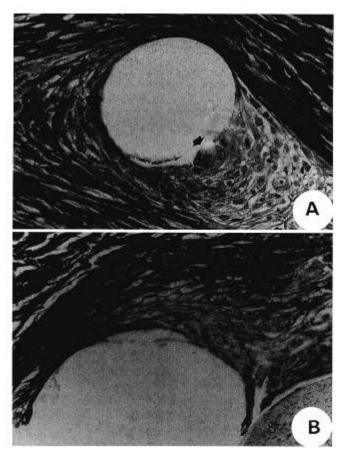
Figure 2. Light photomicrographs of polyvinylidene fluoride sutures at the distal anastomotic site after 1 and 3 months of implantation. At 1 month, the suture is surrounded by fibroblast-like cells, collagen deposits, and a few macrophages (arrow) (A, \times 500). After 3 months, the presence of inflammatory cells around the sutures (S) was rarely observed (B, \times 500).

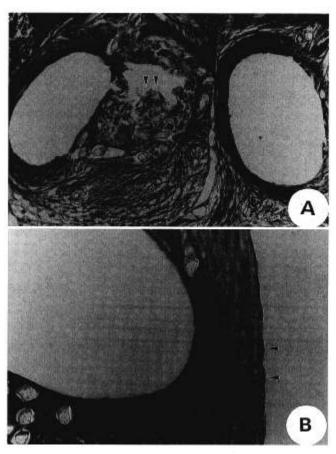
Figure 3. Light photomicrographs of polyvinylidene fluoride sutures explanted at 6 months. The sutures located adjacent to the prosthesis were subjected to a chronic inflammatory response directed toward the polyester fibers (arrows). Nevertheless, they were covered by a thin lining of collagenous tissue (A, $\times 250$). Near the luminal surface, the suture was encapsulated by the newly formed internal collagenous capsule without any inflammatory cells. Endothelial-like cells can be observed covering the collagen tissue (arrows) (B, $\times 500$).

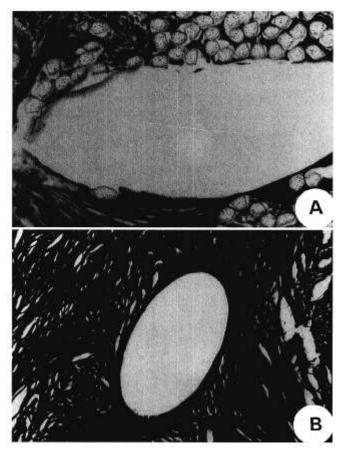
Figure 4. Light photomicrographs of polyvinylidene fluoride sutures after implantation for 1 and 2 years. At 1 year, the suture located in the graft wall was encapsulated by collagen infiltrating the polyester skeleton without evidence of an inflammatory reaction (A, \times 500). Sutures examined after 2 years also revealed complete encapsulation by collagenous tissue without the presence of inflammatory cells (B, \times 500).

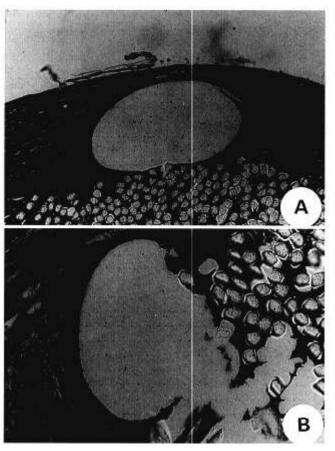
Figure 5. Light photomicrographs of polypropylene sutures retrieved from the anastomotic sites of vascular grafts after 3 and 6 months implantation. After 6 months, the sutures located in the collagenous tissue covering the luminal surface of the graft do not exhibit any inflammatory response (A, $\times 250$). The sutures present in the polyester grafts are surrounded by fibroblast-like cells and collagenous tissue without the infiltration of inflammatory cells (B, $\times 500$).

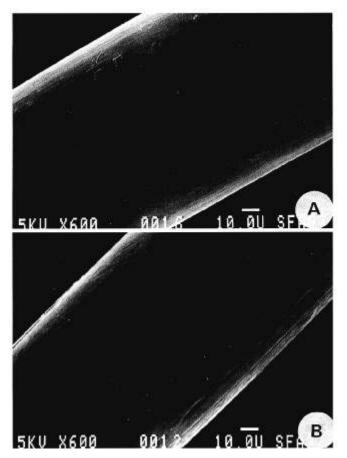
Figure 6. Scanning electron photomicrographs of retrieved and cleaned 6–0 polyvinylidene fluoride sutures showing the surface morphology after implantation for 1 (A, \times 600) and 2 (B, \times 600) years *in vivo*.

The reason why this cracking phenomenon was not observed with the explanted PVDF sutures after 1 year and 2 years *in vivo* is not known at this time. One possible explanation for the apparent superior biostability of the PVDF monofilaments, however, may lie in their less pronounced bicomponent skin/core structure, which is attributable to their different manufacturing history.¹⁷

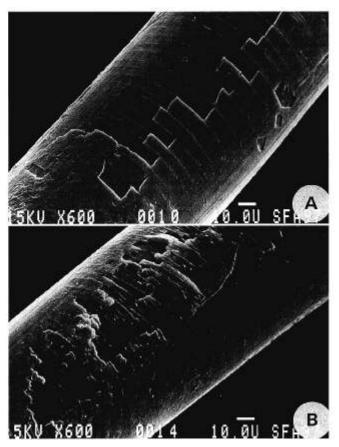
After implantation times of up to 6 months, it was found that the cleaned surfaces of both PVDF and polypropylene sutures were well preserved, without any evidence of surface pitting or cracking. Evidence of iatrogenic trauma was occasionally observed, however, with both types of sutures. This phenomenon is inevitable, and results from the manipulation of the monofilaments with the tweezer or needle holder during the anastomotic procedure. After 1 and 2 years of implantation, the surface of the retrieved and cleaned PVDF sutures did not appear to be substantially modified (**Figure 6**). In contrast, the polypropylene sutures explanted 1 and 2 years postoperatively showed evidence of surface deterioration, characterized by uniformly spaced circumferential cracking and peeling and flaking of the polymer material in the outermost surface layer (**Figure 7**).

Figure 7. Scanning electron photomicrographs of retrieved and cleaned 6–0 polypropylene sutures showing the surface morphology after implantation for 1 (A, \times 100) and 2 (B, \times 600) years *in vivo*.

The reason for this stress cracking phenomenon in oriented polypropylene monofilaments has been explained by their pronounced skin/core structure. This bicomponent structure is created by the differential cooling rates between the external and internal layers of the monofilaments during the melt spinning process, which leads to the formation of a low order nonfibrillar outer skin a few microns thick, and a highly oriented crystalline fibrillar inner core. 33 Blais et al. identified a distinct separation and different properties between these two layers. They found that the outer skin is more susceptible to oxidative degradation than the fibrillar inner core. Cleavage of the polymer chains causes relaxation of the folded lamellae, increases in crystallinity and density, and contraction localized to the outer skin. This in turn leads to regular circumferential crack formation at the surface, but only to the depth of the outer layer.³³ Because this cracking is confined to the outer skin, which is clearly distinguishable from the inner core structure, it is not surprising to observe that, during abrasive stresses, such as cleaning, there was a tendency for the cracked rings at the surface to flake off and separate from the underlying core material (Figure 7).
